## CIVIL AVIATION SAFETY AUTHORITY OF PAPUA NEW GUINEA

### SAFETY ALERT BULLETIN

**NO: 02/2016**

**TITLE:** Primary Flight Control Cable Assembly Retirement.

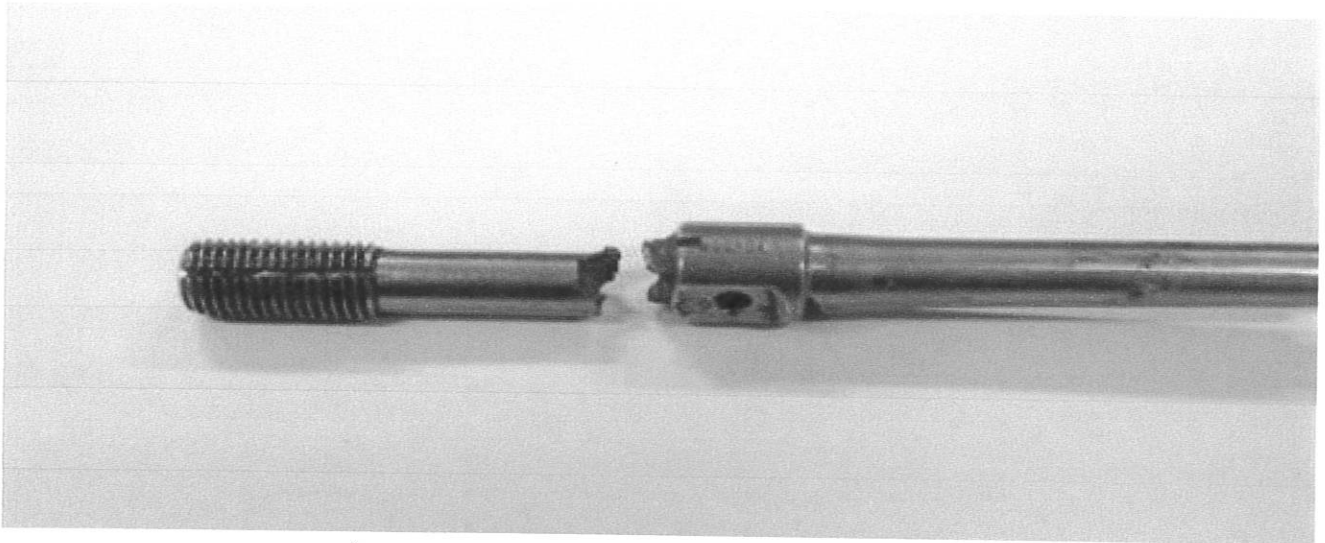
**BACKGROUND:** Reports of flight control cable terminal fitting separation failures continue to be received in Australia, New Zealand and in the United States. Failure of a flight control cable terminal can result in loss of control.

Investigations have revealed that the failed terminals had been in service for approximately 15 years or more and were typically identified by standard terminal fitting part numbers AN669, MS21260 and NAS650.

<sup>6</sup> Figure 1 – Flight Control cable terminal separation.

2. Retire all flight control cable assemblies with terminals made from stainless steel (SAE-AISI 303Se and SAE-AISI 304) including, but not limited to, terminals manufactured to MS20658 (AN658), MS20667 (AN667), MS20668 (AN668), MS21259 (AN666) and MS21260 (AN669 or NAS650), before reaching 15 years total time in service.
3. Where required by aircraft maintenance documentation, flight control cables should be periodically inspected in accordance with the manufacturer's data and FAA AC 43-13-1B Chapter 7, AIRCRAFT HARDWARE, CONTROL CABLES AND TURNBUCKLES, section 8, paragraph 7.149d. To inspect all surfaces of a cable throughout its entire length for wear and fatigue (broken wires) usually requires that the cable be disconnected and removed, to enable a 10X magnifier to be used.

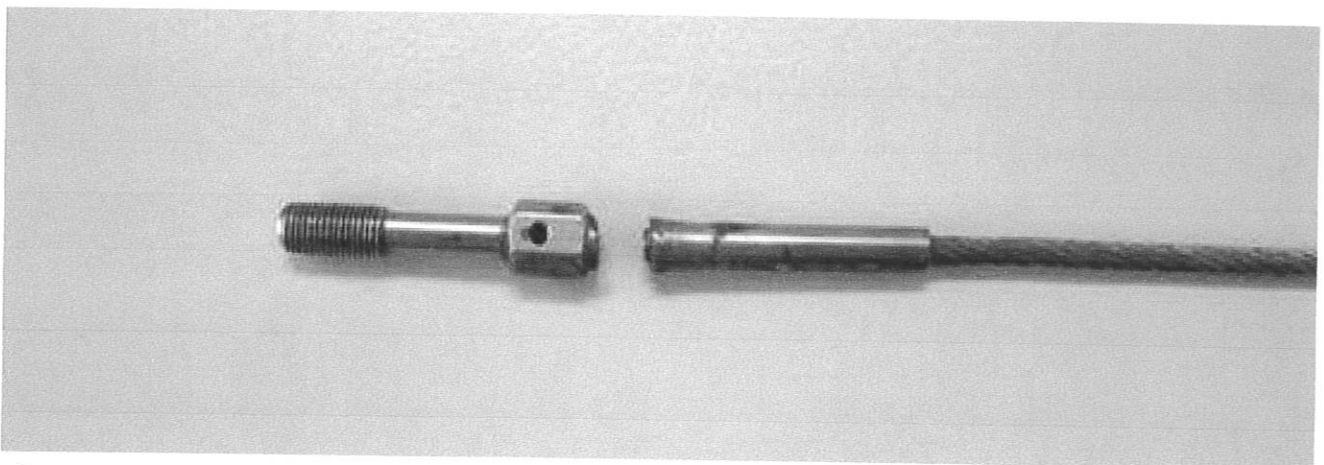
Figure 2 – Flight Control cable terminal separation. Note that the failure has occurred outside the safety lockwire hole.

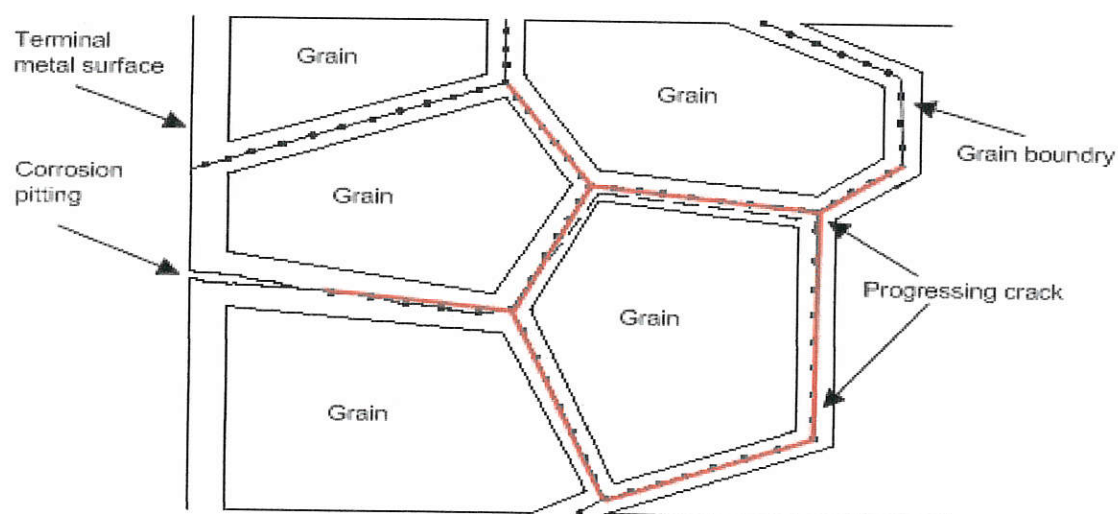
This means that even very small corrosion pits, cracks or rust deposits on the surface of the terminal fitting may be indications that the terminal could be very close to failure.

<sup>3</sup> Figure 3 – Intergranular Corrosion Cracking.

The sketch above (Figure 3) shows small surface pitting can be evidence of advanced intergranular corrosion. Rusty stain deposits, when removed usually reveal areas of small pitting.

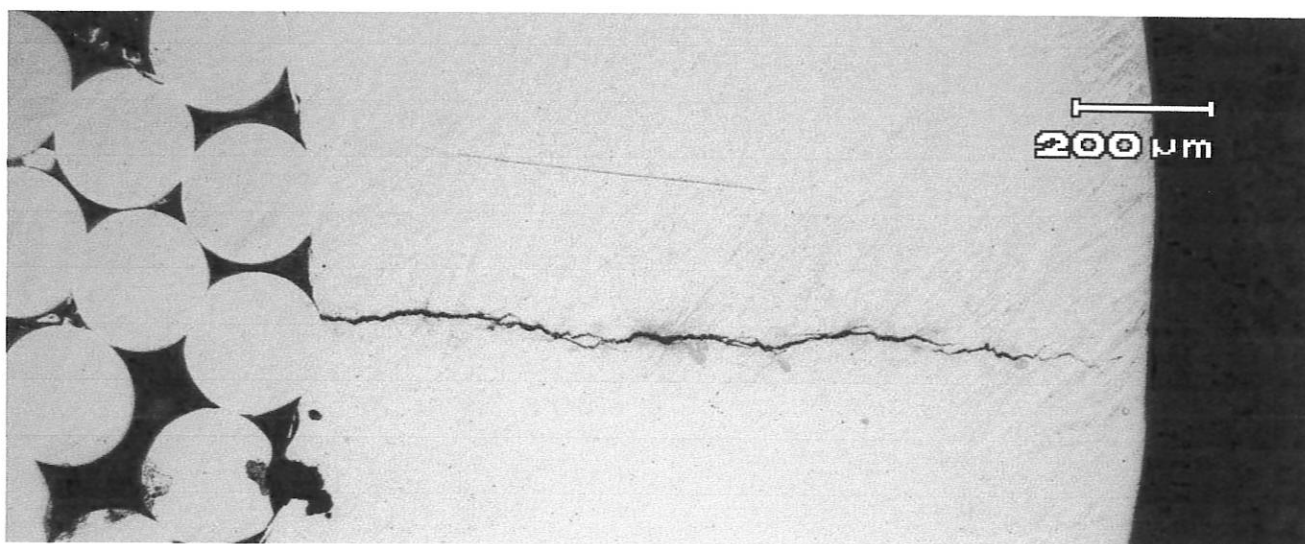
Terminal fitting separation as described in this SAB is due to chloride stress-corrosion cracking (CSCC) a form of intergranular cracking which does not provide clear visual clues to the full extent of the internal structural damage and can originate from within the terminal (See Figure 7).

A formal investigation by the New Zealand Civil Aviation Authority into a report of stainless steel control cable terminal corrosion, discovered evidence of CSCC originating from the inside of the terminal. Since such cracking can originate from within the terminal, external surface clues such as pitting or cracking may not provide an adequate basis for determining serviceability. This introduces the possibility that a terminal may be close to failure and may even fail with little or no surface indication.

Figure 7 – Internal Corrosion – flight control sleeve.

The crack shown in Figure 7 originates from the cable wires (on the left of the picture) swaged in the terminal sleeve. The corrosion has not yet reached the outside surface of the terminal sleeve.
