## CIVIL AVIATION SAFETY AUTHORITY OF PAPUA NEW GUINEA

### SAFETY ALERT BULLETIN

**NO: 02/2016**

**TITLE:** Primary Flight Control Cable Assembly Retirement.

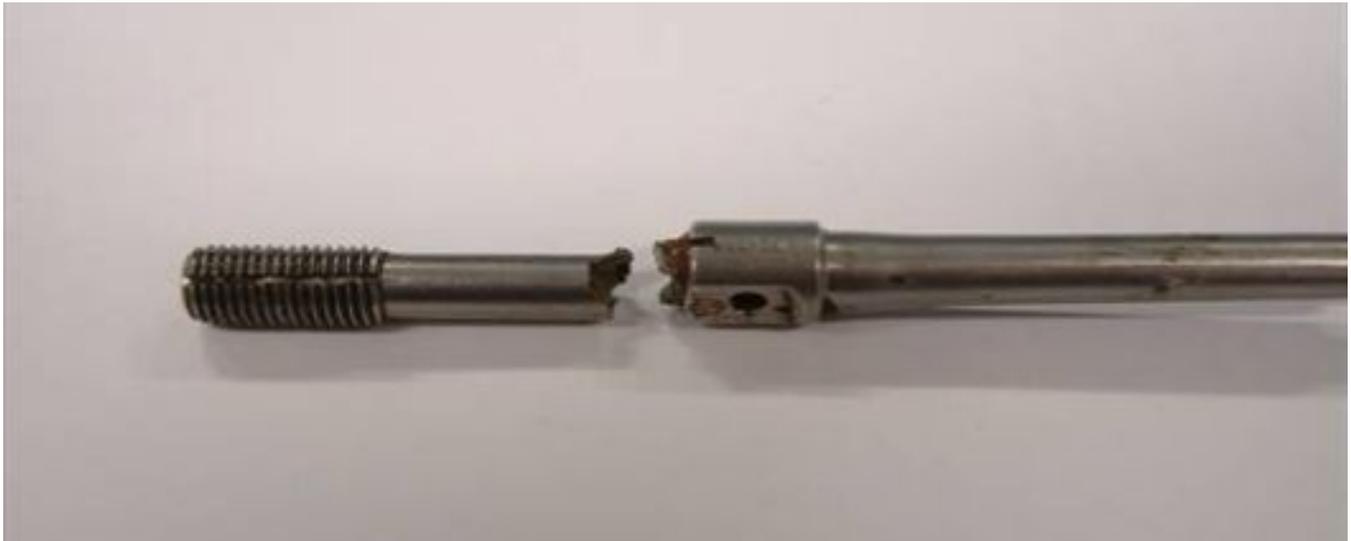
Investigations have revealed that the failed terminals had been in service for approximately 15 years or more and were typically identified by standard terminal fitting part numbers AN669, MS21260 and NAS650.

<sup>6</sup>Figure 1 – Flight Control cable terminal separation.

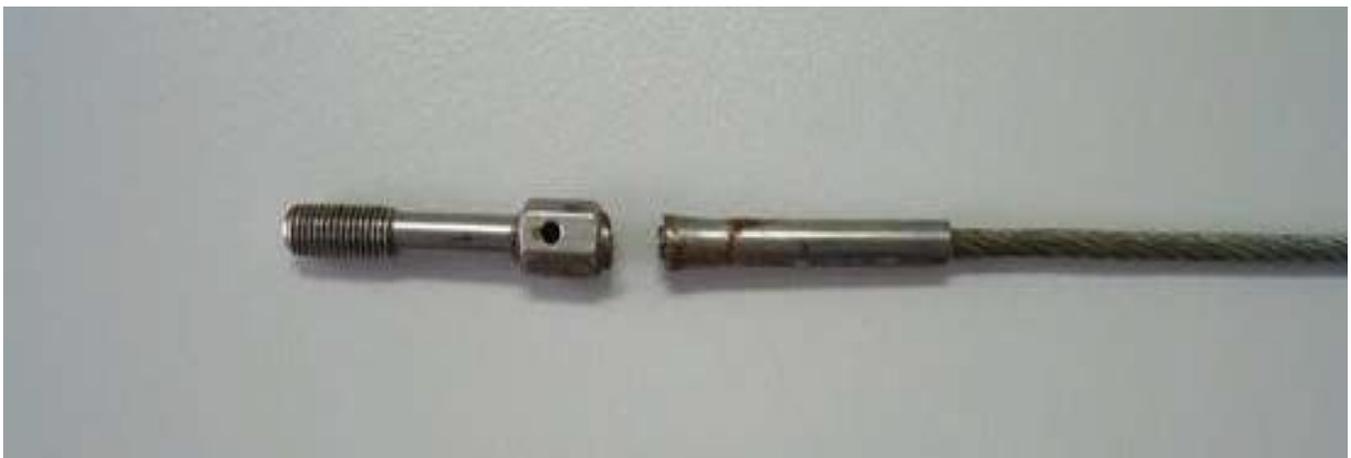
Figure 2 – Flight Control cable terminal separation. Note that the failure has occurred outside the safety lockwire hole.

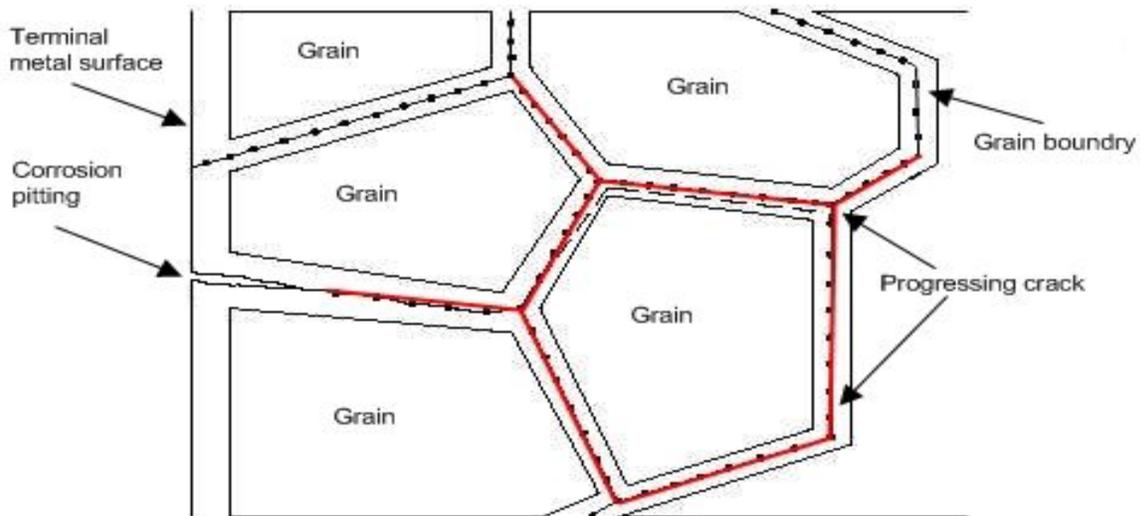
Reported failures in Australia include terminal fittings installed in wings and another in the cabin, and behind the instrument panel (Figure 3). Such locations are generally considered to be free of water, battery gasses and engine exhaust fumes, factors which can contribute to corrosion problems.

<sup>3</sup> Figure 3 – Intergranular Corrosion Cracking.

The sketch above (Figure 3) shows small surface pitting can be evidence of advanced intergranular corrosion. Rusty stain deposits, when removed usually reveal areas of small pitting.

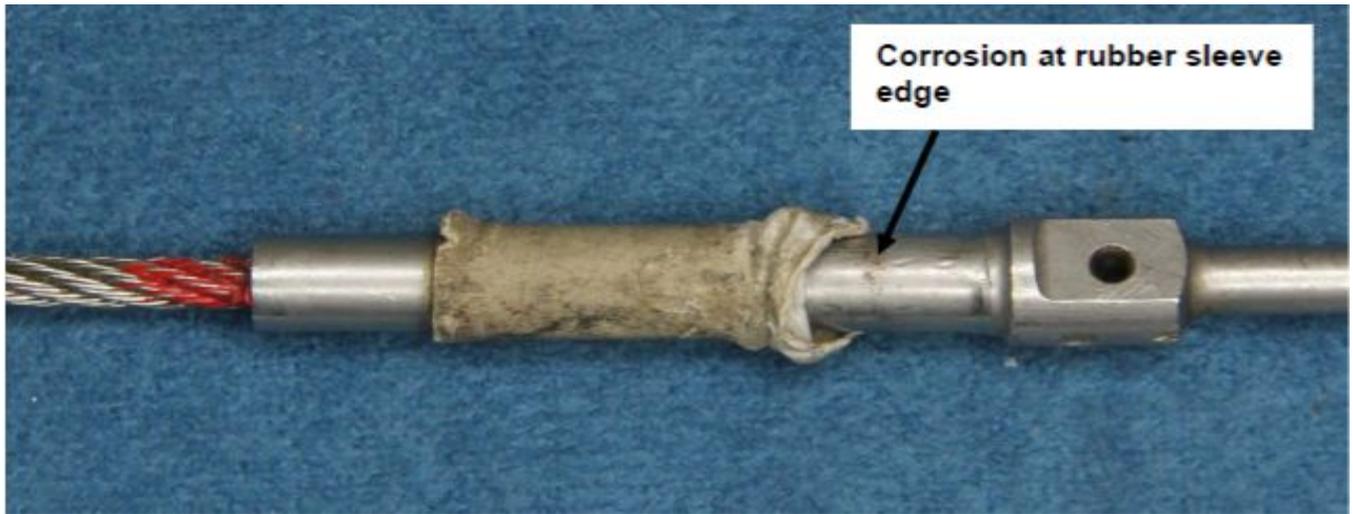
Corrosion pitting has been found under the rubber sleeves and tape wrapped around the terminal to provide part number identification. During an inspection corrosion was detected at the edge of a rubber sleeve, as shown in Figures 4 and 5, below. When the sleeve was pulled back, the maintainer found severe corrosion under the rubber sleeve. A total of four flap control cable terminals were corroded in one aircraft. These flap control terminals had been in service for approximately 13 years.

<sup>4</sup>Figure 4 – Control cable terminal section covered in rubber sleeve.

1. Visually inspect control cable terminals, irrespective of the total time in service, for the presence of any rubber sleeves, tape or any other material/substance (other than lockwire) that may prevent the chromic oxide film from forming. Such material should be removed and the terminal inspected for corrosion, particularly in the area that was covered by the rubber sleeve or tape. Any sign of corrosion is cause for rejection.

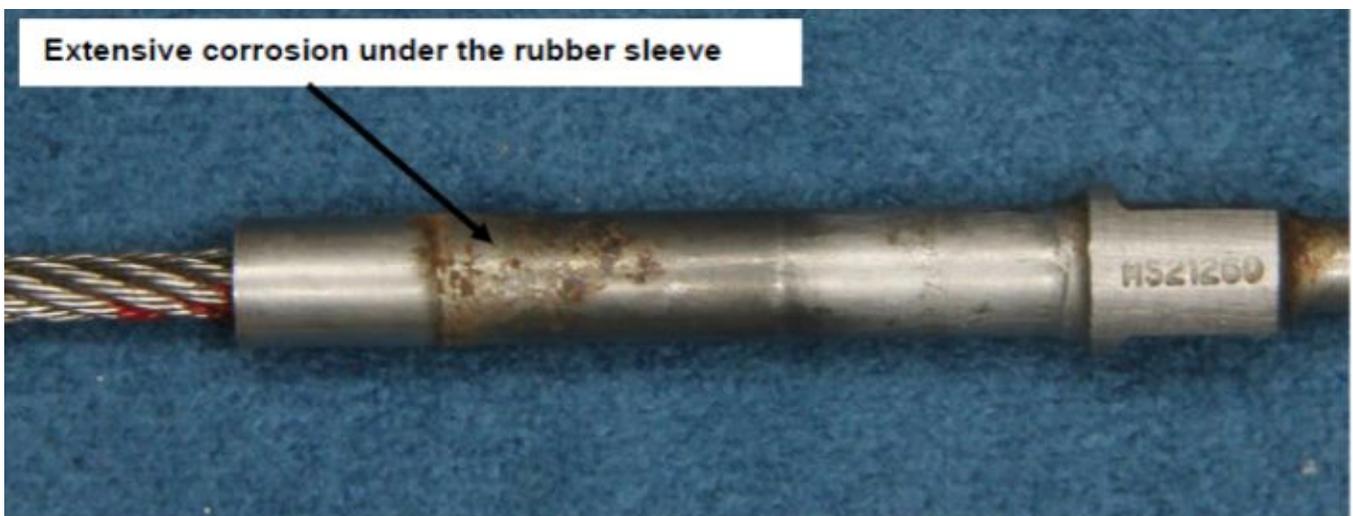
<sup>4</sup>Figure 5 – Control cable terminal shown in Figure 5, with the rubber sleeve removed.  
Note extension corrosion.

Stainless steel's resistance to corrosion is primarily attributed to the existence of a thin chromic oxide film which develops in the presence of oxygen in the atmosphere. Stainless steel must be in continual contact with oxygen in order to develop and maintain the integrity of the film. A breakdown in an area of the oxide film due to lack of oxygen can allow localised corrosion cells to form. The presence of the rubber sleeves or tape over the terminals prevented the chromic oxide film to form, allowing corrosion to develop.

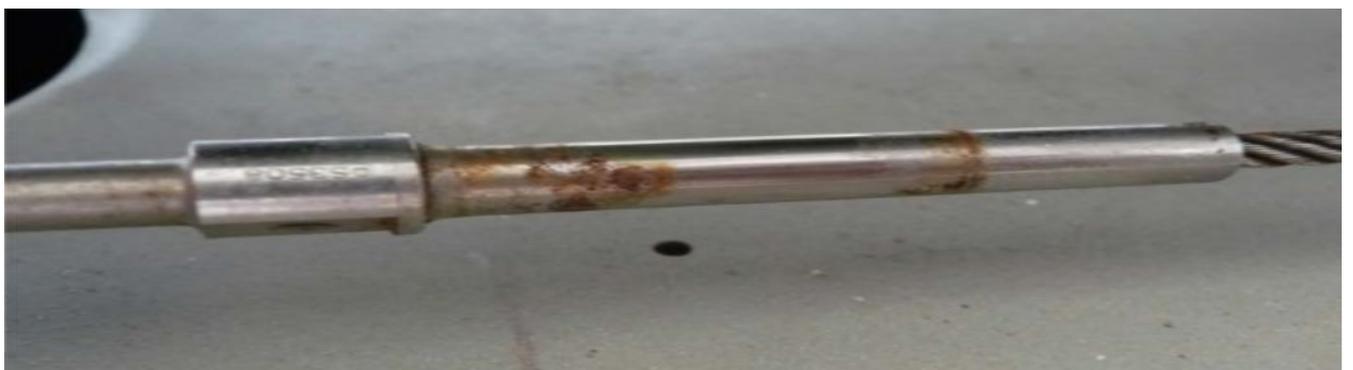
The corrosion on a rudder cable terminal in Figure 6 was also discovered under rubber tubing sleeve installed by the manufacturer. No less than eleven (11) cases of control cable terminal corrosion were discovered on the one aircraft. The cables had been in service for less than 10 years.

<sup>5</sup>Figure 6 – One of the eleven corroded primary flight control cables on the single aircraft.  
Corrosion originated from under the rubber sleeve.

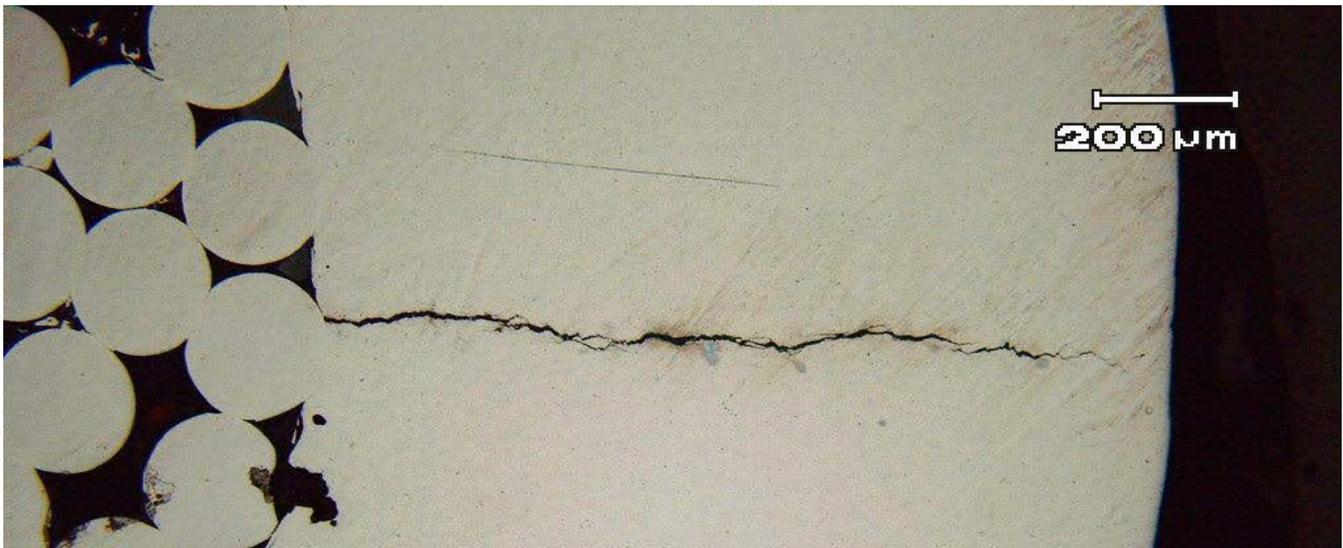
Terminal fitting separation as described in this SAB is due to chloride stress-corrosion cracking (CSCC) a form of intergranular cracking which does not provide clear visual clues to the full extent of the internal structural damage and can originate from within the terminal (See Figure 7).

A formal investigation by the New Zealand Civil Aviation Authority into a report of stainless steel control cable terminal corrosion, discovered evidence of CSCC originating from the inside of the terminal. Since such cracking can originate from within the terminal, external surface clues such as pitting or cracking may not provide an adequate basis for determining serviceability. This introduces the possibility that a terminal may be close to failure and may even fail with little or no surface indication.

Figure 7 – Internal Corrosion – flight control sleeve.

The crack shown in Figure 7 originates from the cable wires (on the left of the picture) swaged in the terminal sleeve. The corrosion has not yet reached the outside surface of the terminal sleeve.

2. Retire all flight control cable assemblies with terminals made from stainless steel (SAE-AISI 303Se and SAE-AISI 304) including, but not limited to, terminals manufactured to MS20658 (AN658), MS20667 (AN667), MS20668 (AN668), MS21259 (AN666) and MS21260 (AN669 or NAS650), before reaching 15 years total time in service.
3. Where required by aircraft maintenance documentation, flight control cables should be periodically inspected in accordance with the manufacturer's data and FAA AC 43-13-1B Chapter 7, AIRCRAFT HARDWARE, CONTROL CABLES AND TURNBUCKLES, section 8, paragraph 7.149d. To inspect all surfaces of a cable throughout its entire length for wear and fatigue (broken wires) usually requires that the cable be disconnected and removed, to enable a 10X magnifier to be used.
