CIVIL AVIATION SAFETY AUTHORITY OF PAPUA NEW GUINEA

SAFETY ALERT BULLETIN

NO: 03/2017

TITLE: Cargo Hooks Systems – Inspection and Maintenance Requirements.

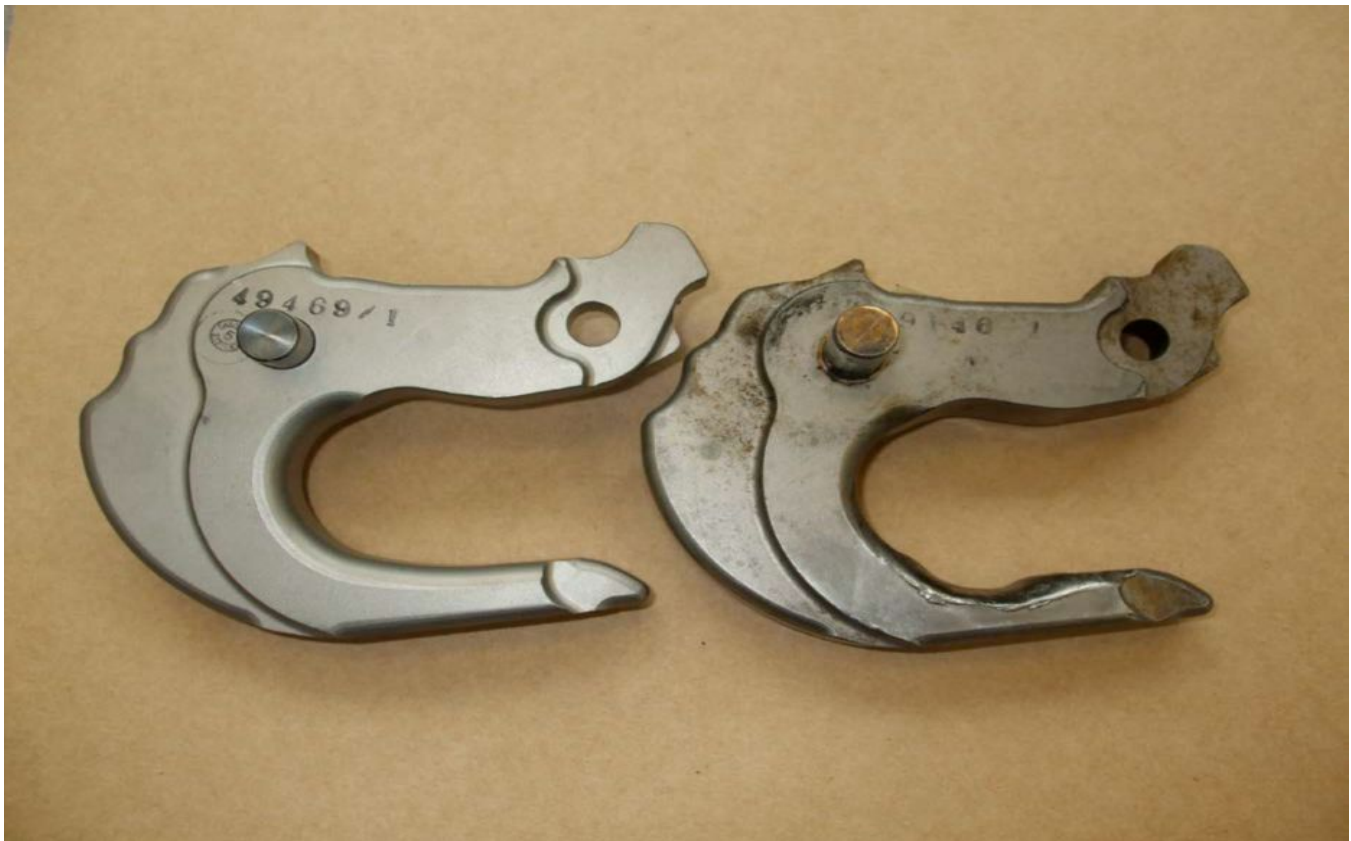
Load beam in the left of the photo – A new replacement part.

Load beam in the right of the photo – Worn beyond manufacturer acceptable limits.

The cargo hook should be removed and cleaned and inspected for following in accordance with applicable manufacturers Component Maintenance Manual (CMM) annually or every 100 hours TIS (whichever occurs first) or at intervals as specified in the applicable CMM.

The CMM provides the wear, gouge and nick limits which are acceptable to the manufacturer.

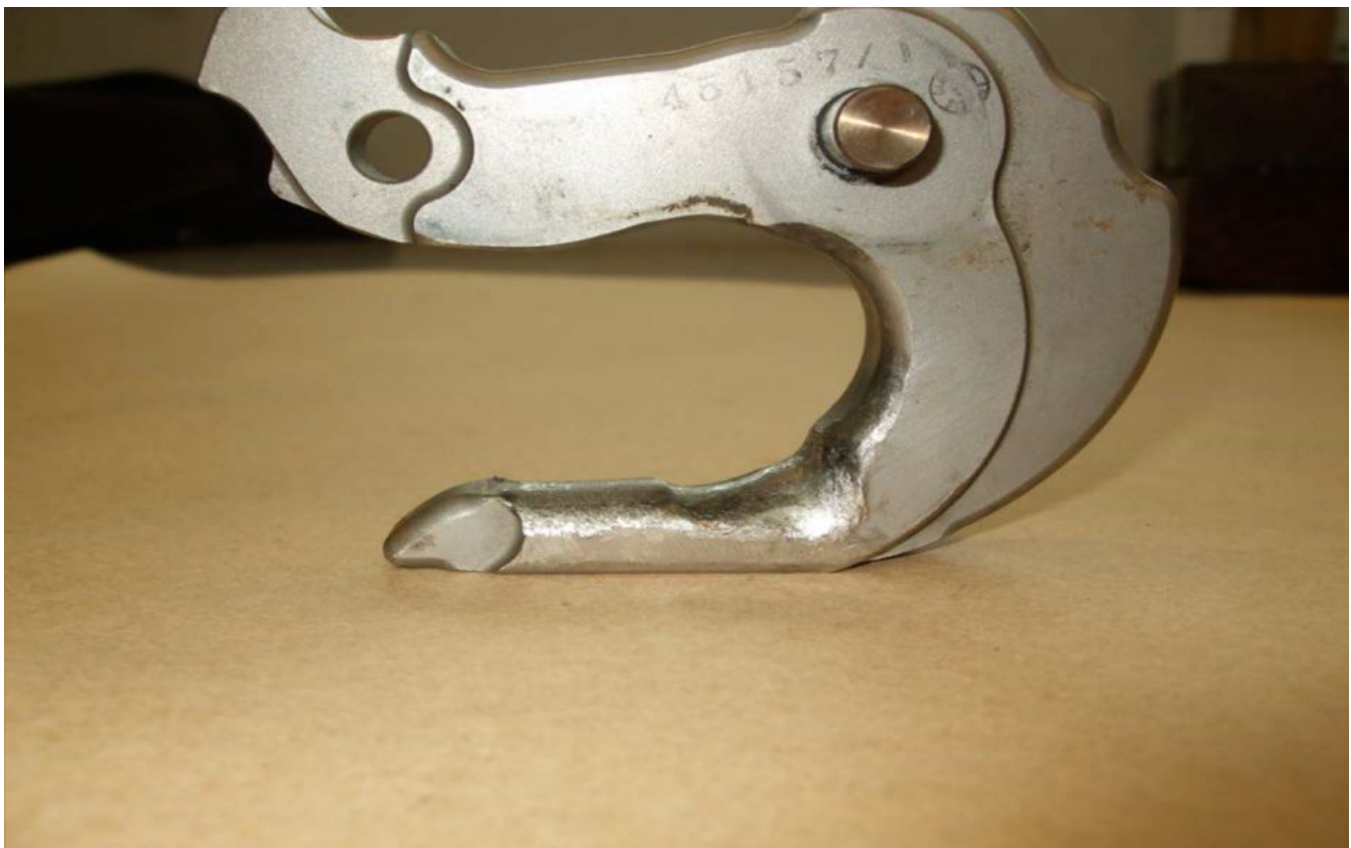
Load beam – Wear beyond manufacturer acceptable limits.

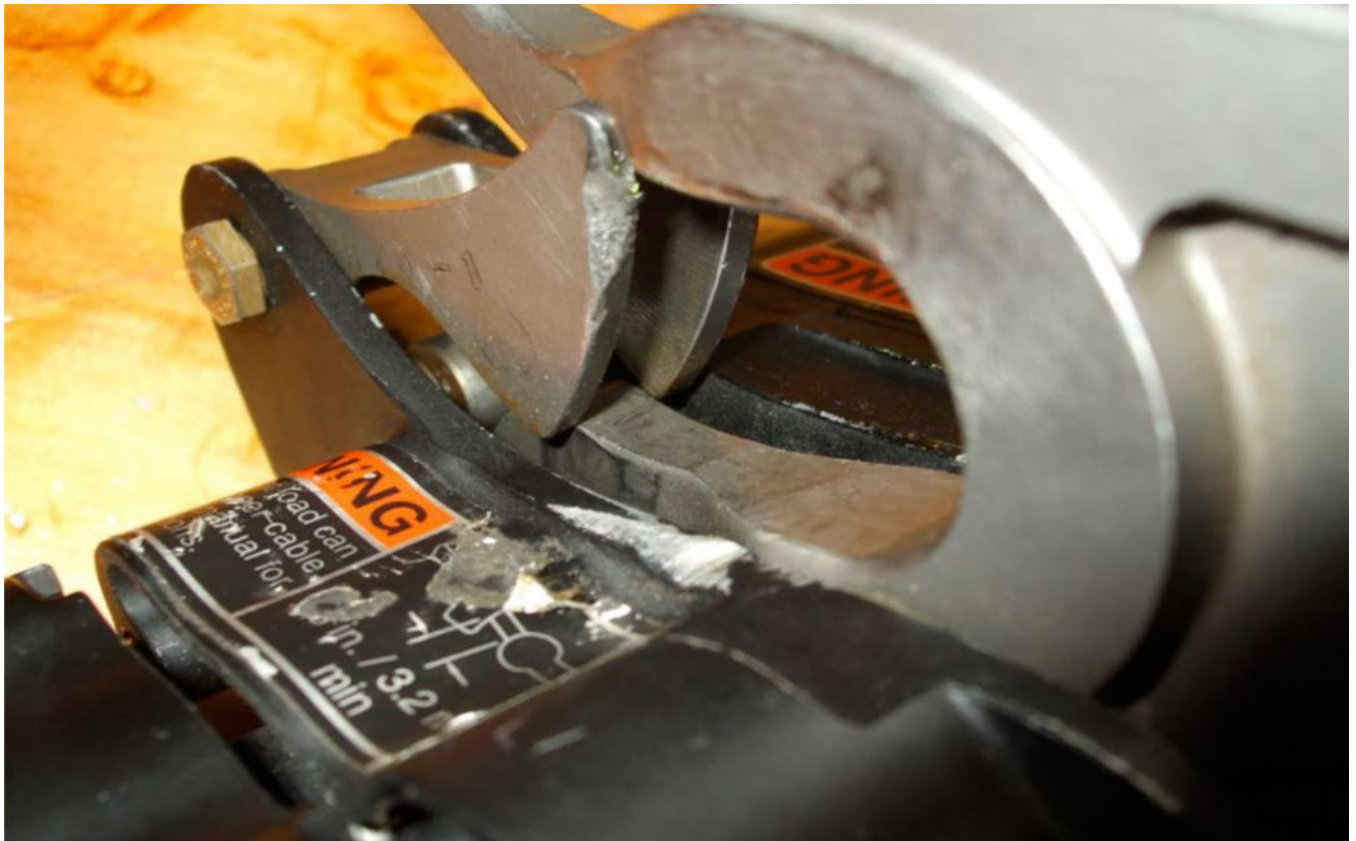
Keeper wear.

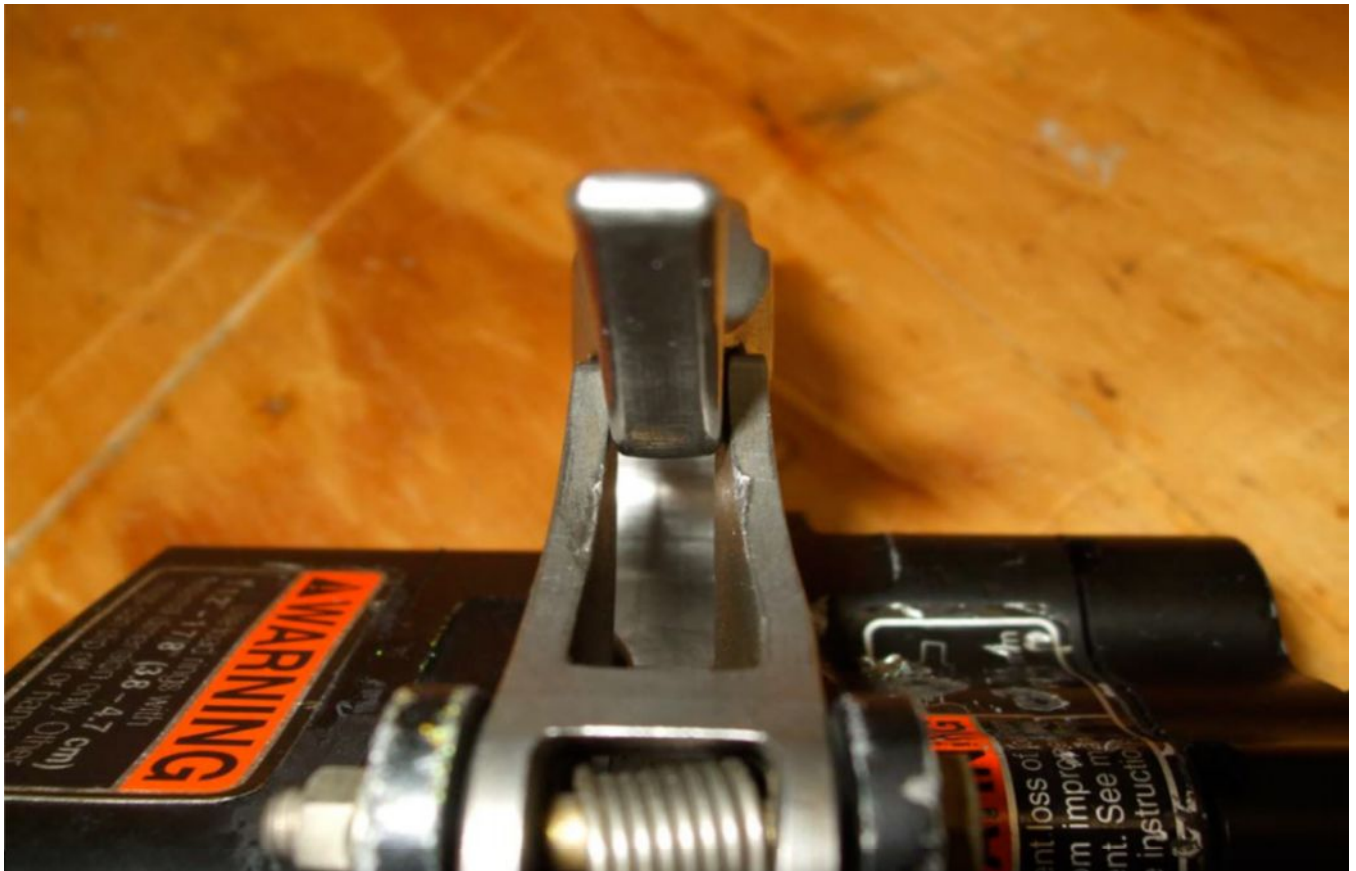
Keeper wear.

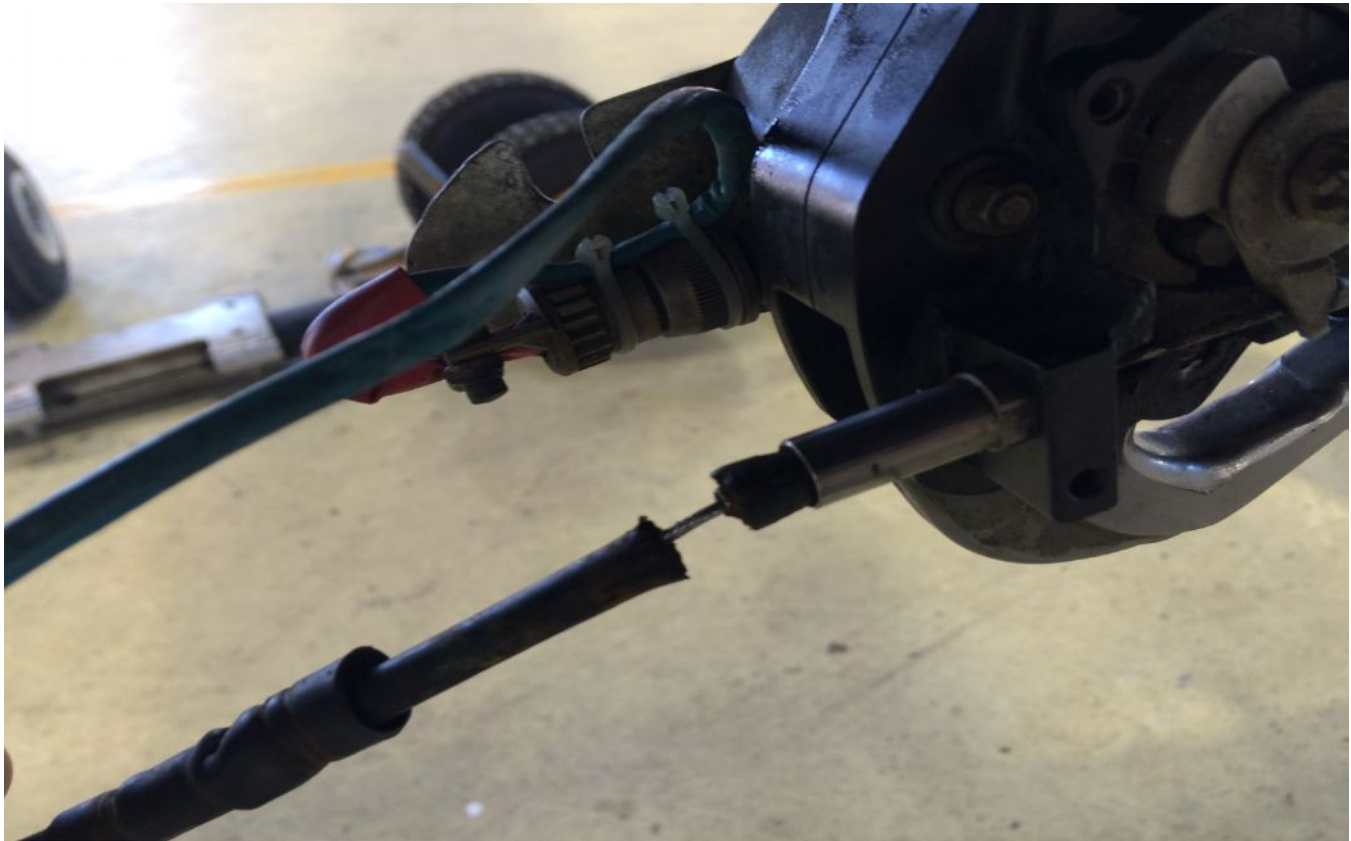
Furthermore, reports have been also received of an inadvertent load release during an external load operation. Investigation revealed that the outer conduit of the manual release cable had broken approximately 50mm forward of the cargo hook with the cable free-play taken up by the cable conduit break. With subsequent in-flight motion of the cargo hook suspension system, the release cable moved sufficiently to activate the hook release mechanism, which resulted in inadvertent load release. Further

investigation revealed that the outer cable conduit may have broken due to cargo hook movement, age hardening/fatigue.

Cable conduit fractured approximately 50mm forward of the cargo hook.

Prior to every external load operation the cargo hook manual release must be inspected for following and if any defects found, accomplish corrective actions before commencing an external load operation in accordance with appropriate CMM/ICA:

- (i) Broken or kinked conduit.
- (ii) Inner cable kinks.
- (iii) Frays and sticky operation.

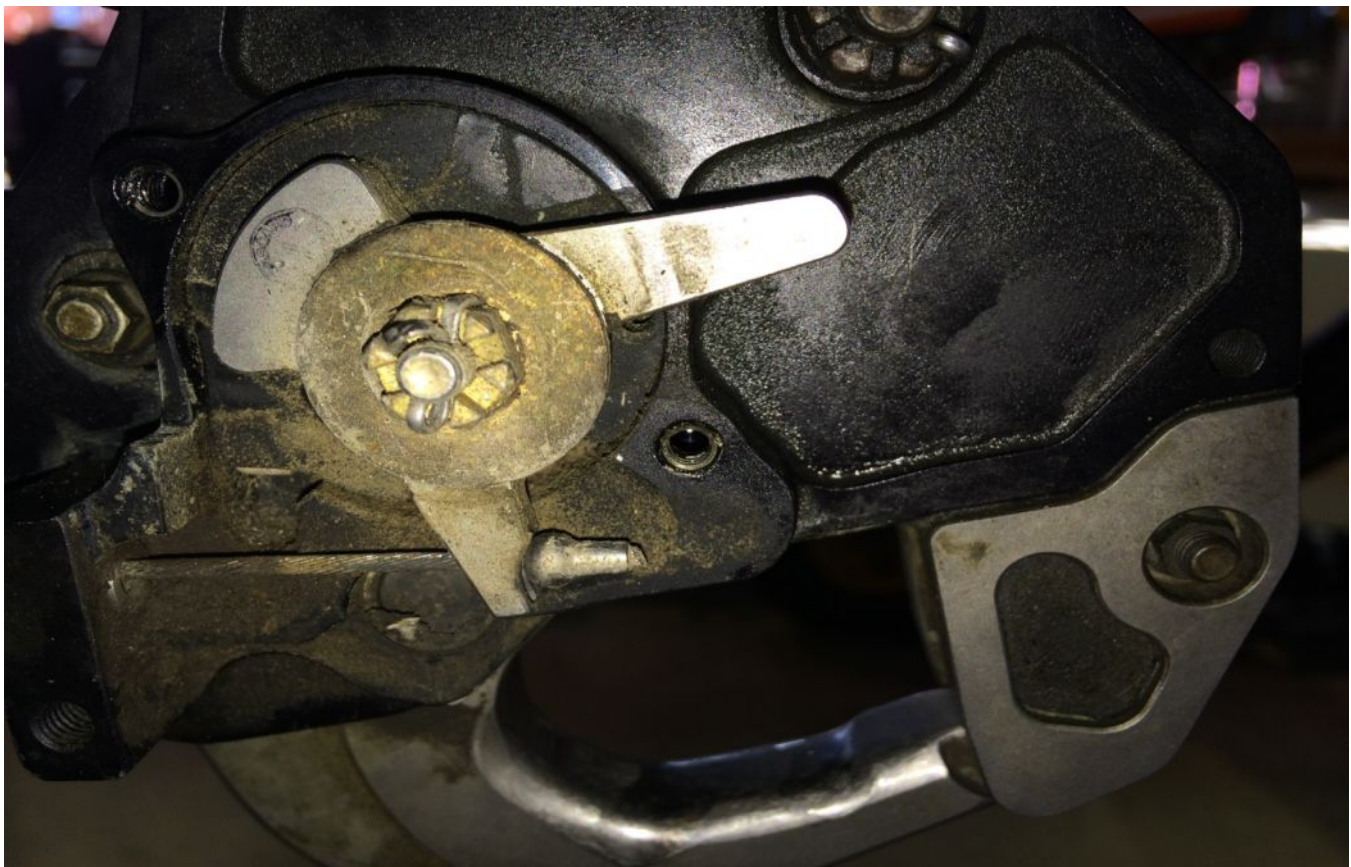
Due to fractured cable conduit, no cable free-play present.
